# Phase I Environmental Site Assessment

Tire Shop

2118 East Abram Street

Terracon Project No. 95137219H

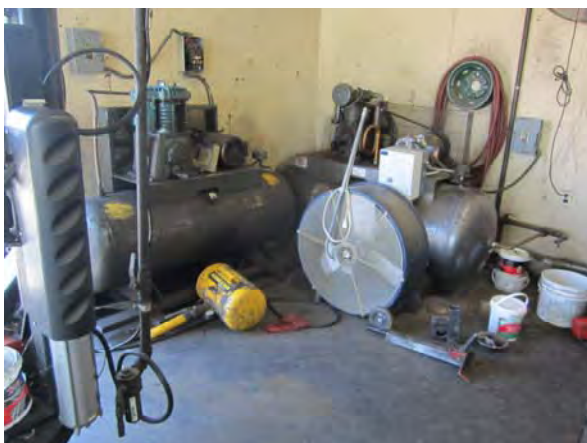
**Photo 5** View of the air compressors on-site.

Terracon observed two air compressors for on-site operations. Staining was not observed in the area of the air compressors. The air compressors do not constitute a REC to the site at this time.

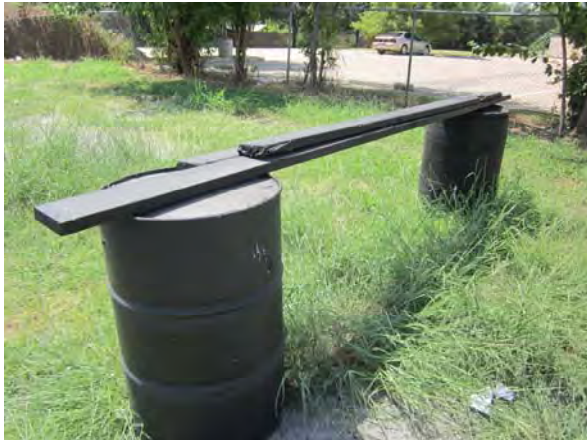
**Photo 7** View of 55-gallon drums on-site.

One unlabeled 55-gallon drum was observed on the exterior east side of the building. Staining was observed in the area of the drum. The staining appeared to be de minimis in nature and does not constitute a REC to the site. Two empty 55-gallon drums were observed on the south side of the lot with treated wood planking them. Staining was not observed in the area around the drums.

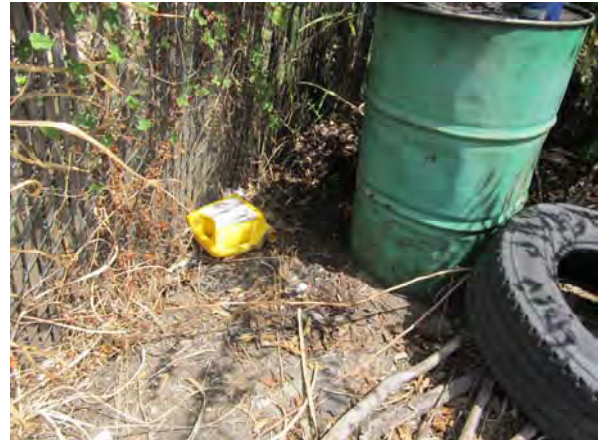
**Photo 8** View of the 55-gallon drum and soil staining.

As stated previously, stained soil was noted in the above drums section and does not constitute a REC to the site.

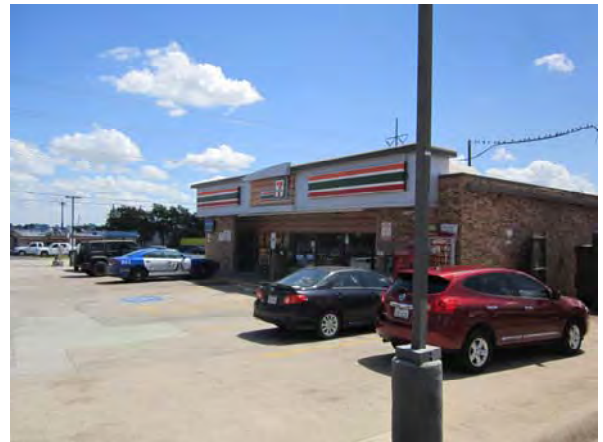
**Photo 10** View of the east adjoining 7 Eleven.

7 Eleven located on the east adjoining property at 2120 East Abram Street, is listed on the NOV, PST, LPST, GWCC and FRSTX regulatory databases. According to the NOV database, in 2003 four violations were reported for the facility pertaining to failure to maintain a stage II vapor recovery system and related components documents. The violations were resolved and no additional violations have been reported. The PST database indicates that three 10,000-gallon gasoline underground storage tanks (USTs) were installed in 1979 and were removed from the ground in 2008. One 15,000-gallon gasoline and one 10,000-gallon gasoline USTs were installed at the facility in 2008. The LPST database indicates that in 2006, a release was detected at the facility and groundwater was determined to be impacted. The TCEQ issued final concurrence and closed the case. The GWCC database indicates that in 2006 a gasoline release was identified at the facility. The action was completed and the remedy was considered complete.

PST Program action levels for benzene-0.240 mg/L (over 0.005 mg/L) and MTBE-7.50 mg/L (over 0.36 mg/L). The Water was removed from the tank hold and during the installation of the new USTs, the monitoring well was damaged and was plugged and abandoned. A new monitoring well was installed on November 14, 2008 and three soil samples were collected and all were below the PST Program action levels. All groundwater monitoring wells were sampled on January 21, 2009 and MW-1R exhibited concentrations of MTBE at 0.477 mg/L; the groundwater sample collected from MW-1 exhibited benzene and MTBE concentrations above the PST Program action levels at 0.264 mg/L and 1.11 mg/L, respectively. Due to a TPH detection in MW-2, PAH was also analyzed. The PAH results were below the PST Program action levels. It was stated that the facility was already an active LPST facility and the assessment activities have been in progress since 2006. Groundwater monitoring events indicated that groundwater flow direction is to the east-southeast, away from the site. By February 2010, additional groundwater monitoring events indicated that benzene was above the Category II Target Cleanup Levels in MW-1R and MW-2. The plume was determined to be stable and located beneath the concrete parking surface and therefore, no further action was recommended. On April 22, 2010, the TCEQ granted closure to the 7-Eleven facility. Based on the historical regulatory information reviewed, the 7-Eleven facility does not appear to constitute an REC.
